Reinforcing A Weak Foundation

BY JAKE LEWANDOWSKI

In my article, “A Partial Foundation Retrofit” (Jun/19), I mentioned two locations that needed attention in this client’s foundation. In that article, I focused on where the existing foundation had lost all structural integrity and needed to be completely replaced. Here, I address the second location, where the engineer deemed that the existing foundation—though weak—would just require reinforcing.

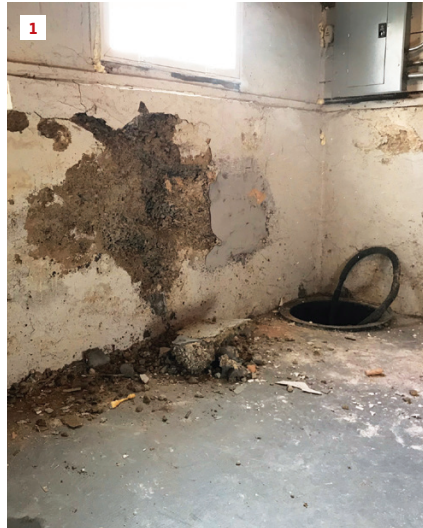
This area of the existing foundation was weak but still structurally sound (1). In their investigation, the crew discovered that there was no footing under the original foundation (2) and turned to an engineer for a solution.

The solution was pouring what we call a “bench wall,” which is basically a reinforced retaining wall poured against and tied into the original foundation wall. Before starting, we checked an area where the slab had broken and discovered that there was no footing under the original wall. The engineer’s answer was to excavate under the original foundation in alternating 2-foot sections, supporting the old wall while allowing the new concrete footing to extend into the voids under the wall.

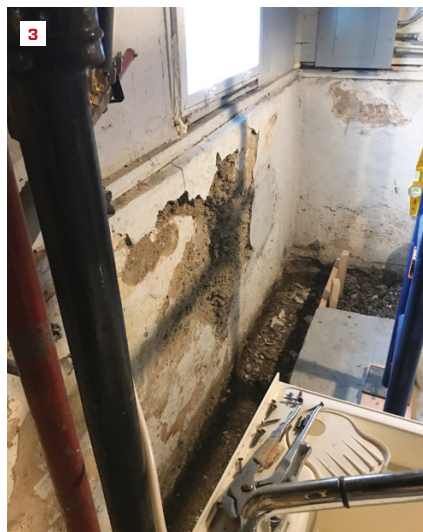
The crew cut the slab and dug a footing trench 1 foot wide and 1 foot deep (3). Under the wall, they dug 2-foot-wide voids 2 feet apart that would be filled with concrete as part of the new footing. A special tool bends rebar into the needed shapes (4).

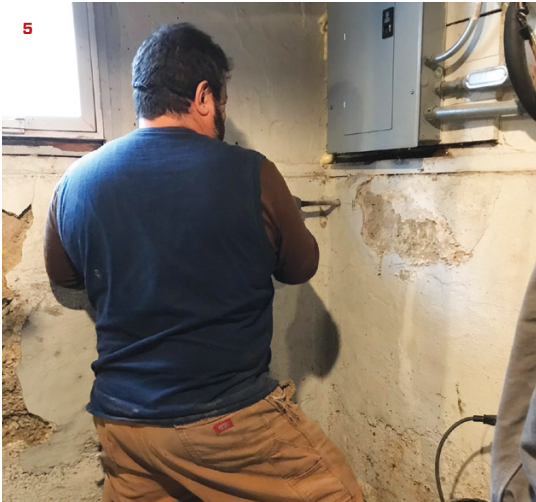
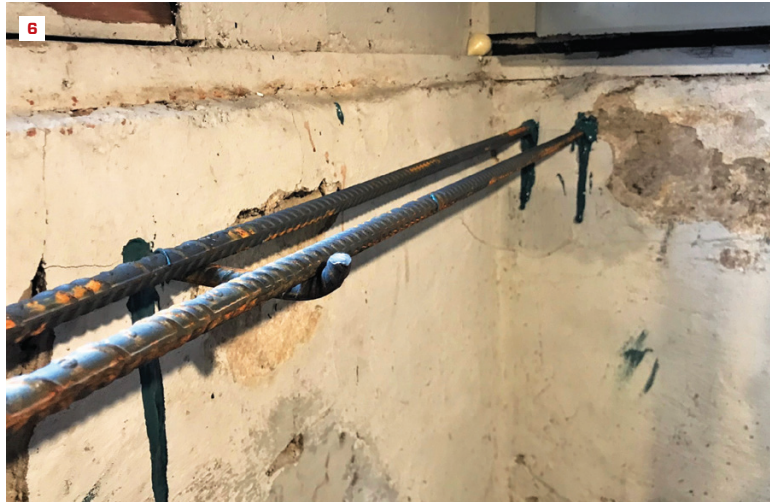
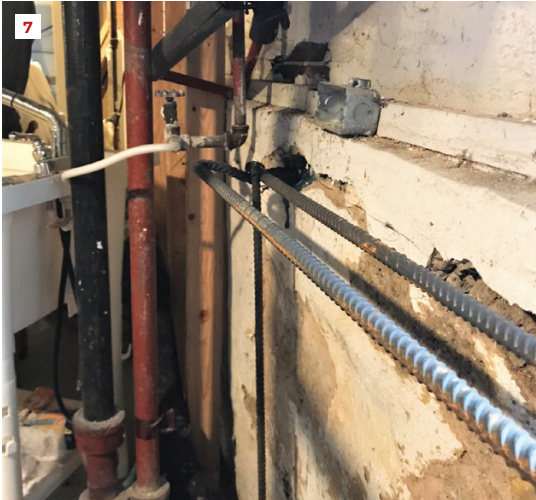
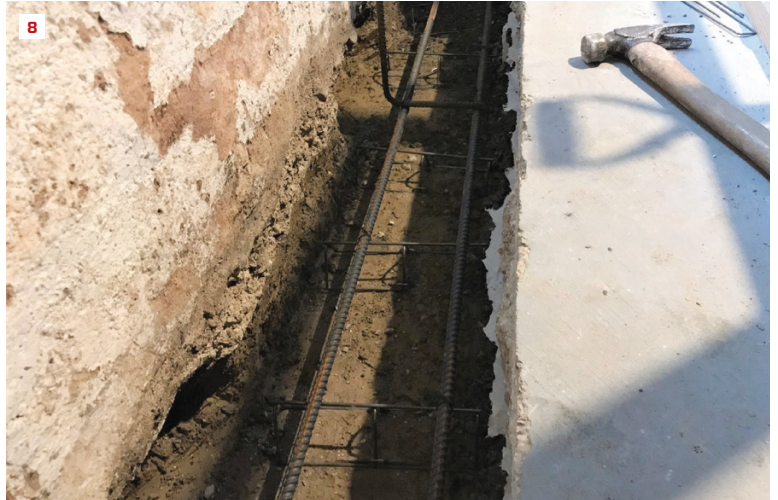
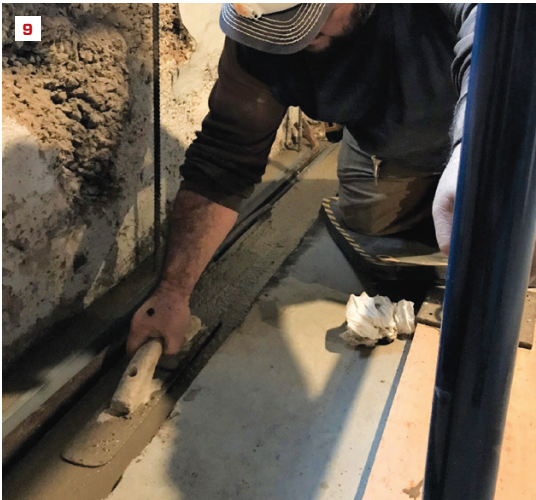
Rebar was essential for tying the new bench wall to the existing foundation. A crew member started by drilling holes at the top of the adjacent foundation walls (5), then used high-strength epoxy to attach two lengths of rebar at one end of the wall (6). Short lengths of rebar drilled and epoxied into the foundation wall provide support for the rebar along its length. At the other end, the rebar was bent and epoxied into the existing wall (7). The ends of the vertical and horizontal lengths were tied together for the pour. In the footing trench, lengths of rebar were set on chairs pinned to the base of the footing (8). One of the 2-foot voids dug out under the existing foundation every 2 feet is visible in the foreground. The concrete for the footing extended into these holes to support the existing wall. The crew mixed and poured concrete for the footing from bags, troweling the top for a smooth surface (9).

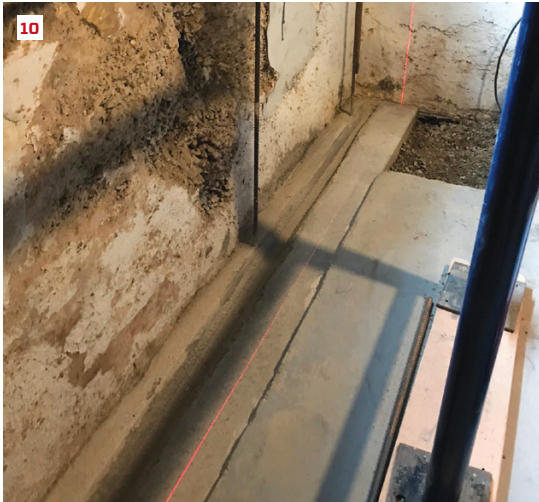
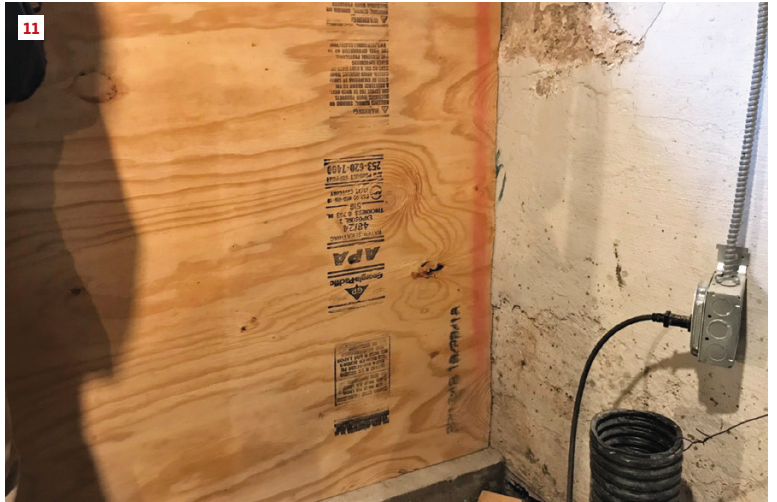
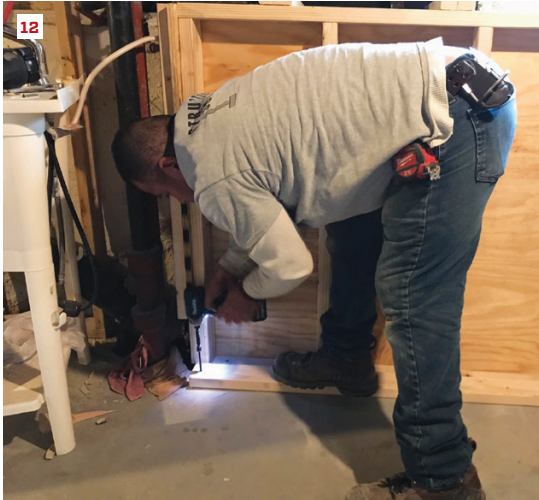
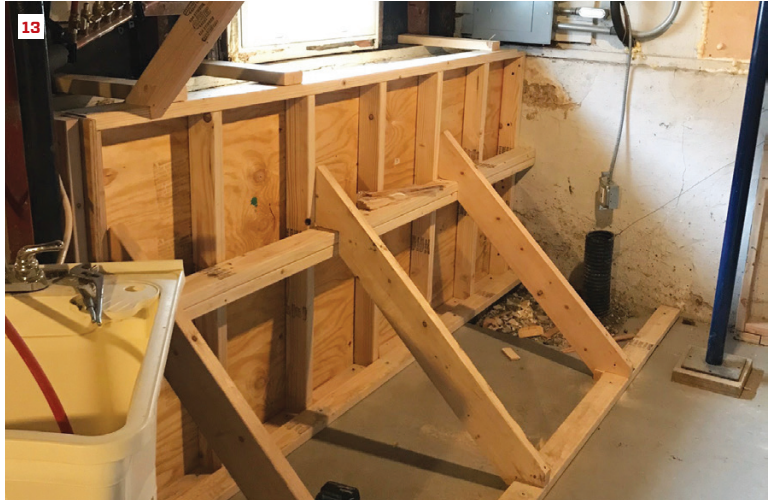
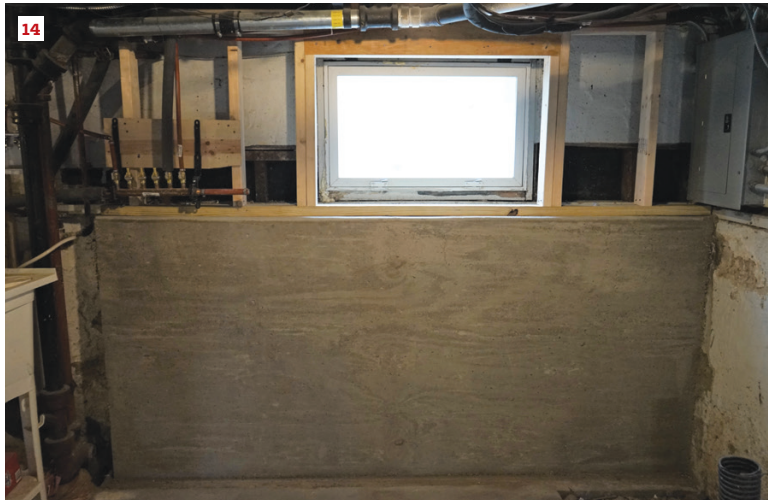
A keyway cast into the footing helped to lock the bench wall in place (10), while a laser line was used to guide placement of the form. After scribing the form plywood to the adjacent wall (11), the crew built a frame for the form. A 2x4 anchored to the slab held the bottom of the form in place (12). To ensure that the form didn't move or bow out during the pour, the crew attached a horizontal strongback across the middle (13). Diagonal 2-bys braced back to the floor provided additional support. After placing the concrete and allowing it to set for a few days, the crew stripped the form and framed a 2x4 wall tight between the bench wall and the joists above (14). In addition to the wall helping support the floor and exterior wall loads, pressure on the wall added to the lateral stability of the bench wall.

Once the bench wall was poured on top of the new footing, we framed a tight-fitting 2x4 wall between the floor joists and the top of the concrete. This wall helped support the exterior wall load and the floor load, and it also helped the newly poured wall resist buckling horizontally.
