# Common Deck Stair Defects

**Build deck stairs according to best practices rather than code to protect your customers and avoid liability**

by Bruce Barker

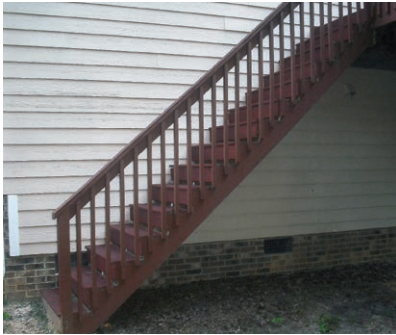
**Figure 2.** Allowing the toe of the seat cut to be the only part of the stringer that bears on the landing can cause the stringer to shear along the wood grain. At least  $1 \frac{1}{2}$  inches of the heel of the seat cut should bear on the landing.

can cause the stringer to shear along the wood grain (**Figure 2**).

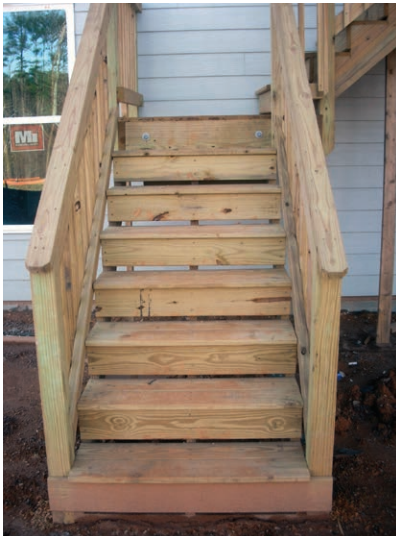
**Figure 4.** Nails driven through a dropped header into the end grain of a stringer (above left) have minimal resistance to withdrawal. Toenailed stringers are less susceptible to withdrawal, but the connection can still fail as the framing ages and is structurally compromised (above center). At a cost of a few dollars each for the connectors and recommended fasteners, the most cost-effective way to hang a stringer is with metal hardware. But this one (above right) has been installed incorrectly, since the stringer isn't fully bearing on the connector seat. Another red flag: drywall screws instead of approved connector fasteners.

**Stringer attachment.** One of the most serious deck stair defects is a poor connection between the stringers and the deck. Failure at this important connection is common, particularly when the stringers have been nailed to the framing, because nails are subject to withdrawal.

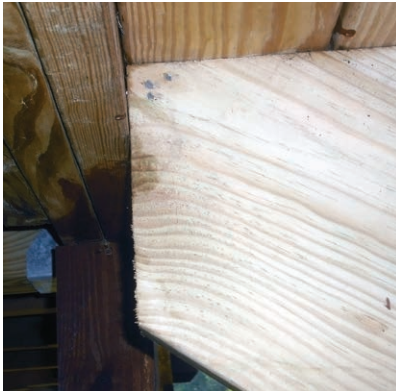
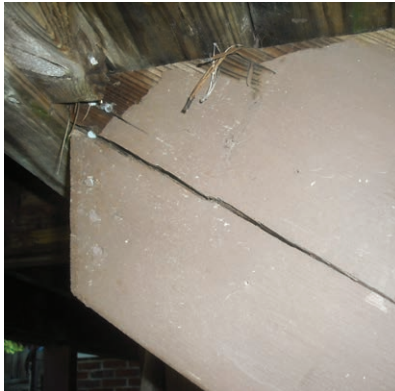
**Figure 3.** Stringers require adequate bearing on either a rim joist or a dropped header. Without it, the risk is that the stringer will split along the grain (left). The photo on the far left is new construction that was approved by the local building inspector.

**Plumb cut.** For maximum plumb-cut bearing and fastening area, the ideal stringer position has the top tread even with the deck flooring, which allows the stringer plumb cut to fully bear on the rim joist or beam. This location makes installing the stair guards and handrails more difficult, however, so it's more common to see the top tread dropped one riser below the deck flooring. Unfortunately, I've found that this often leads to unsafe attachment details with inadequate bearing that can allow the stringer to shear along the grain (**Figure 3**).

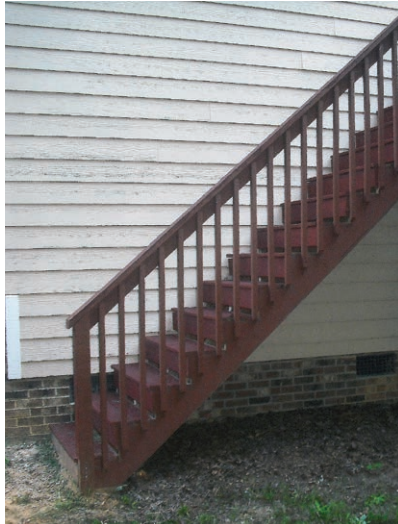
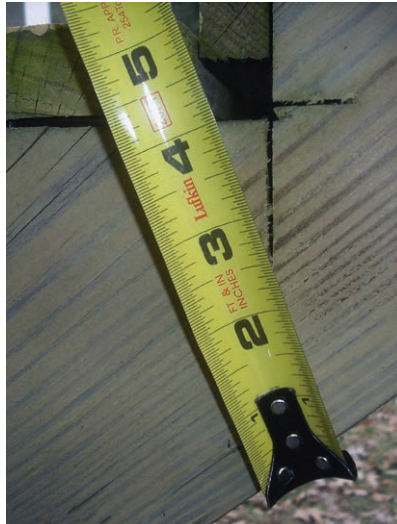
**Figure 5.** A 2x12 stringer has a maximum unsupported span of 6 feet. These stairs are likely to deflect and cause the stringers to either pull loose from the framing or shear along the grain (far left). The problem is made worse with overcut notches, which weaken a stringer. The minimum recommended depth of the uncut portion of the stringer is 5 inches, as measured to the closest saw kerf, and not the notch itself.

The minimum recommended size for a deck stair stringer is 2x12, which has a maximum recommended unsupported span of 6 feet. Often this maximum span is dangerously exceeded, resulting in overspanned stringers that will deflect and cause the connection at the deck to pull loose and fail. In some cases, overspanned stringers may shear along the wood grain (**Figure 5**).

The minimum recommended depth of the uncut portion of the stringer is 5 inches. The measurement is to the saw kerf, and it's common to find stringers with dangerously overcut notches. Stringers that are overcut have the same potential failures as overspanned stringers. In both cases, they can be repaired by installing intermediate support posts.

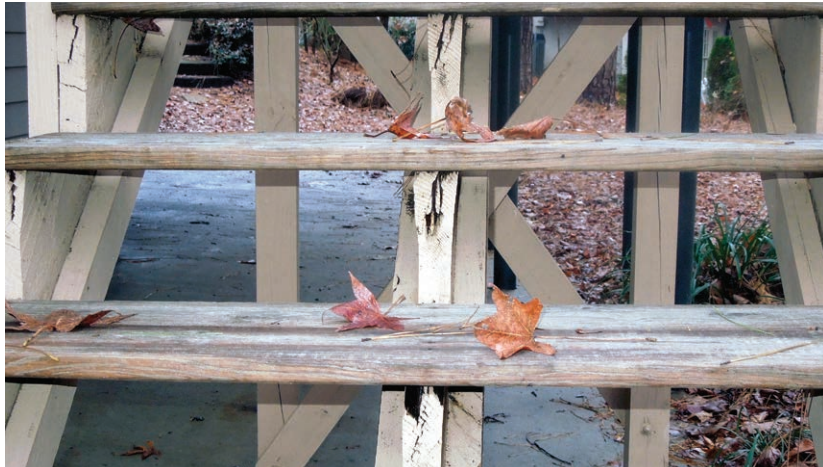
**Figure 6.** Stairs that are higher than 30 inches off the ground are subject to the same guidelines as railings, so avoid open risers that permit the passage of a 4-inch-diameter sphere.

Many deck builders seem to be unaware that open risers allowing a 4-inch-diameter sphere to pass through are not permitted on stairs that are more

than 30 inches above grade (or the floor below) (Figure 6). This is a common defect in older decks, but I often find it on newer decks too.

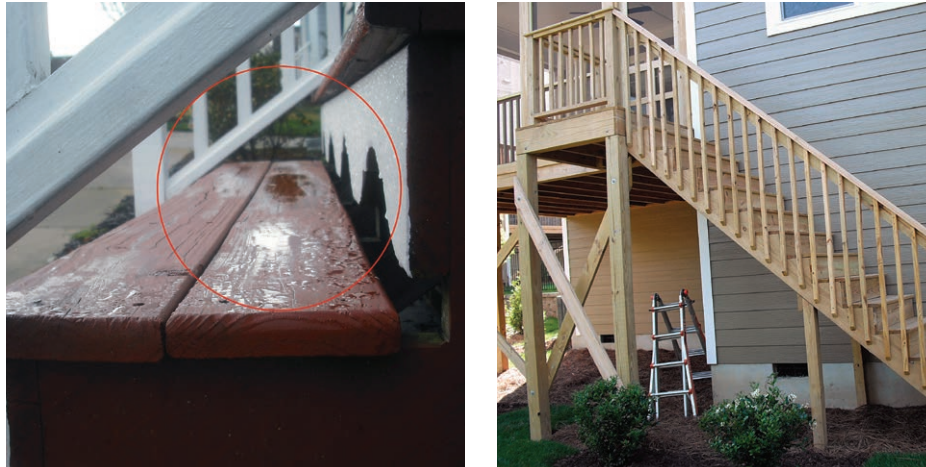
Figure 8. Bottom guard rails on stairs should be oriented close enough to the tread nosings so that a 6-inch-diameter sphere will not pass through the triangle created by the riser, tread, and rail (far left). Wooden stair guard posts should be located so that the span between posts (as measured horizontally) is no more than 6 feet. This is a new deck that passed inspection (left).

Guards for deck stairs share the same requirements as guards for interior stairs (Figure 7). Two of the more common stair-guard defects I see include failing to install vertical infill components so that a 4 $\frac{3}{8}$ -inch-diameter sphere will not pass through, and failing to install the guard bottom rail so that a 6-inch-diameter sphere will not pass through the triangle created by riser, tread, and guard bottom rail (Figure 8).

In addition, 4x4 wood support posts for stair guards should be installed so that they are no more than 6 feet apart. Post spacing must be measured horizontally, not along the length of the guard.

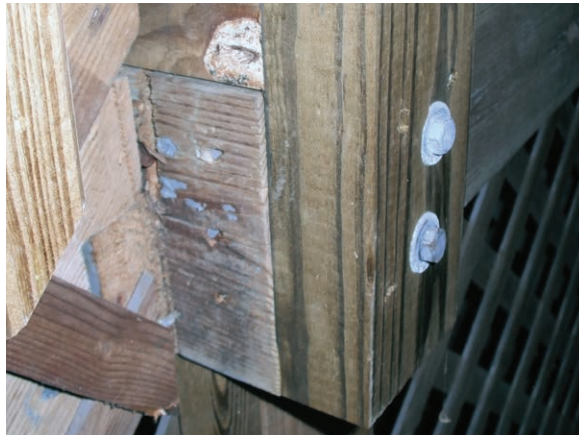
**Figure 10.** Avoid notched posts, which may develop cracks originating in the corner of the notch and running parallel to the grain, which weakens the post (far left).

Posts should never be notched around the framing, because that practice increases the odds that the post will develop cracks that originate in the corner of the notch and run parallel to the

grain, weakening the post (**Figure 10**).

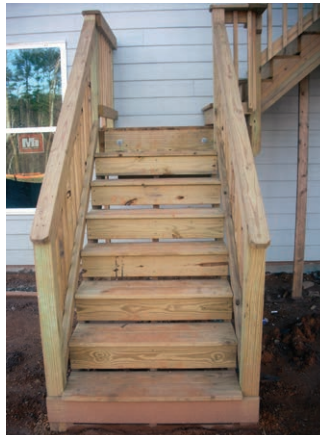
**Figure 11.** Though common, 2x4 handrails are not considered graspable and should be avoided.

with code or best practices, including those with typical 2x4 and 5/4 rail caps (**Figure 11**). A 2x4 handrail is not graspable, especially by children and others with small hands, the elderly, and those with impaired mobility—the people who need a safe, graspable handrail the most.

Deck stair handrails should also be continuous from above the top tread or landing to above the last tread in the flight of stairs, and terminate in a return or into a support post. If the guard is properly installed otherwise (which it often isn't), the easiest fix for most handrail problems is to install a separate graspable handrail.
